**DOT/FAA/TC-17/18**

# **Effects of Repair Procedures on Bonded Repairs of Airframe Structures**

November 2017

Final Report

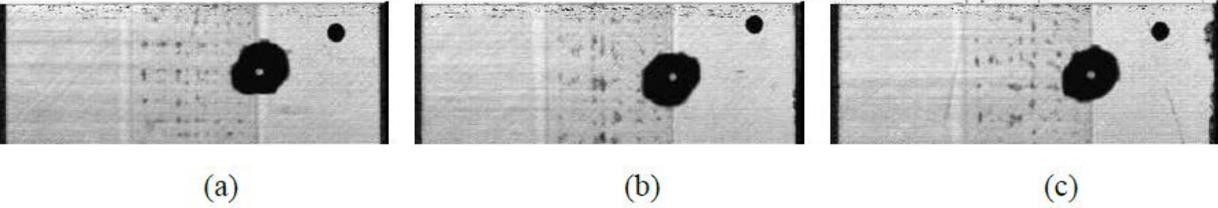
**Figure 77. C-scans of 48-ply-E2-10-TN-RTA of damage area and depth, respectively: (a) 1.91 in<sup>2</sup>, 0.0085 in; (b) 1.88 in<sup>2</sup>, 0.011 in; (c) 1.87 in<sup>2</sup>, 0.0085 in**

Figure 73 shows C-Scan planar damage areas for all 48-ply scarf repairs after impact. Figures 74–85 are representative C-Scan images obtained for all specimens subsequently tested at room temperature. As shown in figure 73, for both substrate moduli considered and regardless of scarf ratio, the TN impacts yielded the smallest damage areas followed by the TF impacts and the CN impacts. The same energy level inflicted at different sites in the repair yielded different damage sizes, with the impacts inflicted at the CN being the most severe. A close examination of the C-scans shows a large scatter in the damage areas obtained for identical samples impacted with the same energy level.

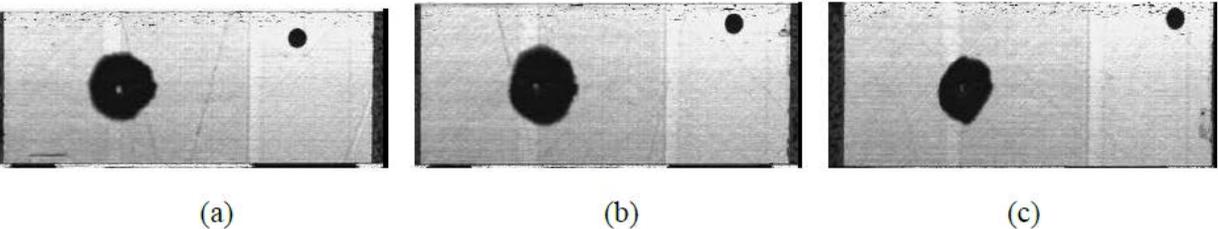
**Figure 78. C-scans of 48-ply-E2-10-TF-RTA of damage area and depth, respectively: (a) 2.56 in<sup>2</sup>, 0.011 in; (b) 2.92 in<sup>2</sup>, 0.009 in; (c) 1.75 in<sup>2</sup>, 0.013 in**

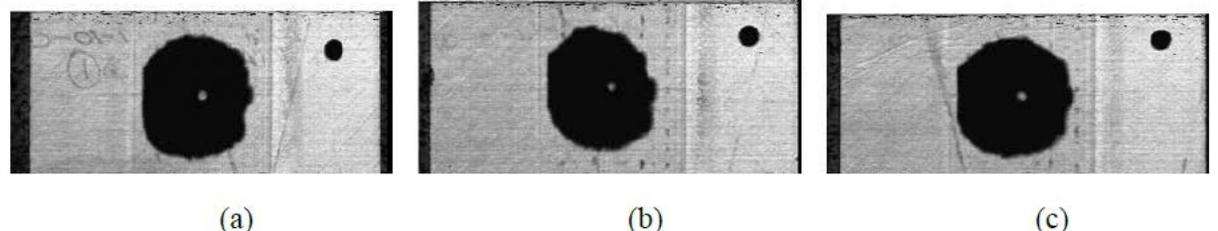
**Figure 79. C-scans of 48-ply-E2-10-CN-RTA damage area and depth, respectively: (a) 7.22 in<sup>2</sup>, 0.008 in; (b) 6.30 in<sup>2</sup>, 0.008 in; (c) 7 in<sup>2</sup>, 0.008 in**

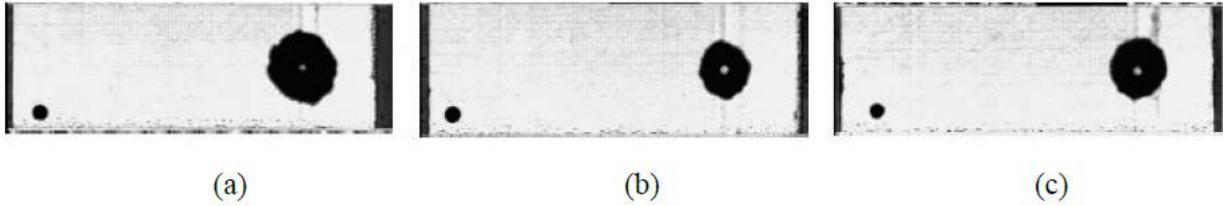
**Figure 80. C-scans of 48-E1-20-TN-RTA-(1, 2, 3) of damage area and depth, respectively:  
 (a) 2.8312 in<sup>2</sup>, 0.0105 in; (b) 2.0252 in<sup>2</sup>, 0.01 in; (c) 3.894 in<sup>2</sup>, 0.011 in**

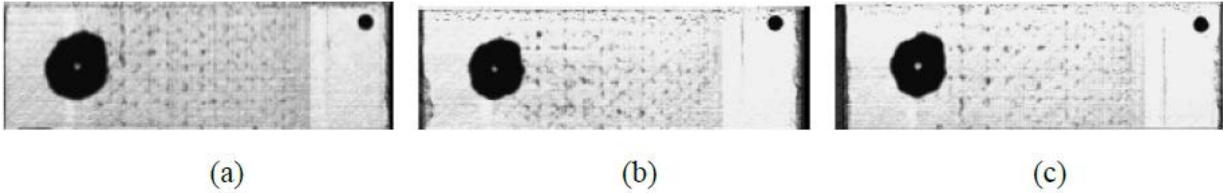
**Figure 81. C-scans of 48-E1-20-TF-RTA-(1, 2, 3) of damage area and depth, respectively:  
 (a) 3.4948 in<sup>2</sup>, 0.0105 in; (b) 2.8096 in<sup>2</sup>, 0.012 in; (c) 2.7856 in<sup>2</sup>, 0.012 in**

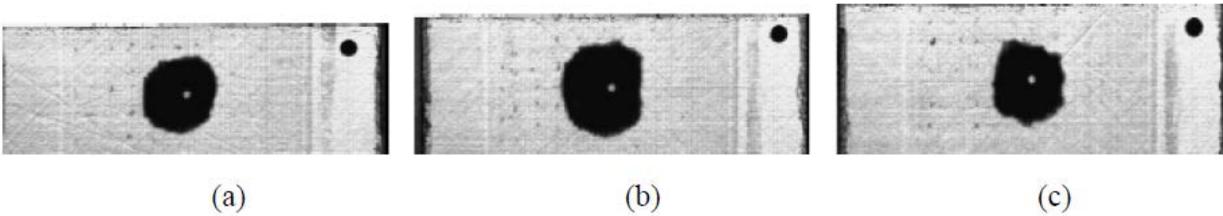
**Figure 82. C-scans of 48-E1-20-CN-RTA-(1, 2, 3) of damage area and depth, respectively:  
 (a) 3.9376 in<sup>2</sup>, 0.008 in; (b) 5.2012 in<sup>2</sup>, 0.0075 in; (c) 3.6064 in<sup>2</sup>, 0.008 in**

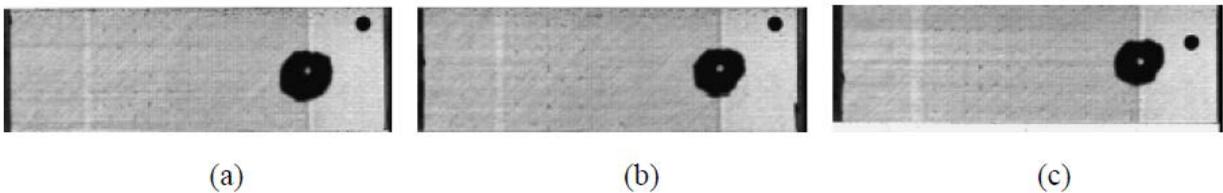
**Figure 83. C-scans of 48-E2-20-TN-RTA-(1, 2, 3) of damage area and depth, respectively:  
 (a) 2.118 in<sup>2</sup>, 0.01 in; (b) 2.016 in<sup>2</sup>, 0.011 in; (c) 1.914 in<sup>2</sup>, 0.0095 in**

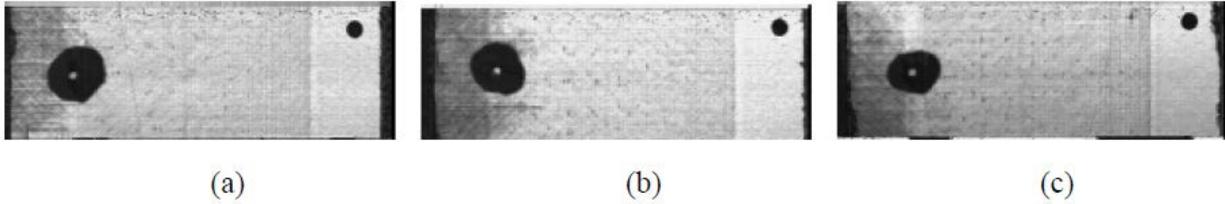
**Figure 84. C-scans of 48-E2-20-TF-RTA-(1, 2, 3) of damage area and depth, respectively:  
 (a) 2.326 in<sup>2</sup>, 0.0075 in; (b) 1.968 in<sup>2</sup>, 0.0085 in; (c) 1.602 in<sup>2</sup>, 0.0085 in**

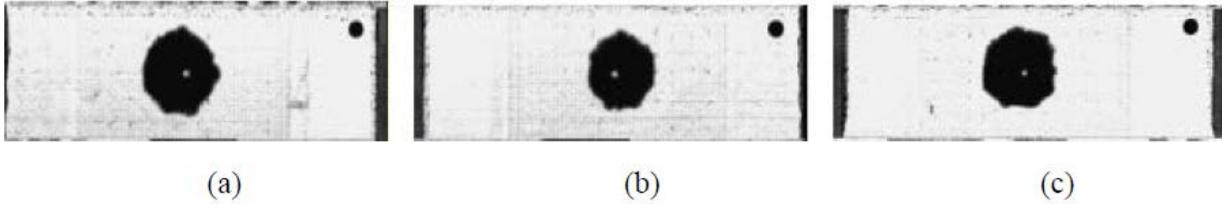
**Figure 85. C-scans of 48-E2-20-CN-RTA-(1, 2, 3) of damage area and depth, respectively:  
 (a) 4.9112 in<sup>2</sup>, 0.009 in; (b) 3.7932 in<sup>2</sup>, 0.0095 in; (c) 4.9392 in<sup>2</sup>, 0.0115 in**

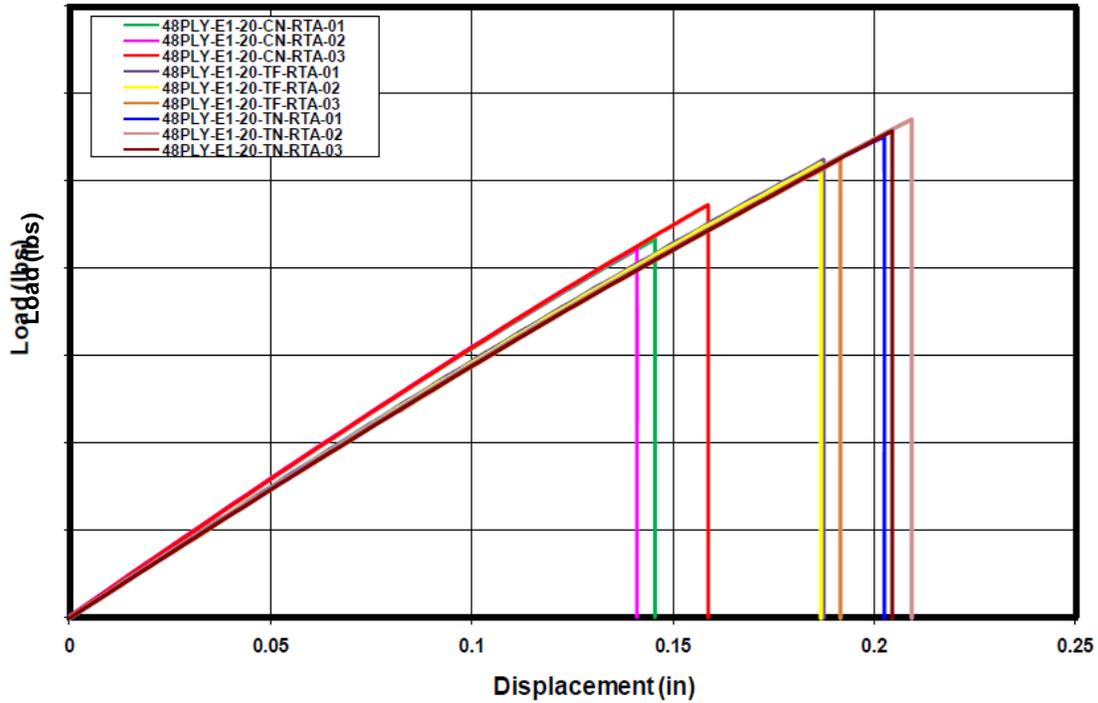
Figure 86. Representative load vs. displacement curves of damaged 48-ply laminate scarf repairs tested at room temperature (1:20 scarf rate)

Figures 86 and 87 show representative load displacement curves of damaged 48-ply scarf repairs tested at room temperature. Figure 88 shows a summary of the failure loads obtained for all damaged static samples tested at room temperature. These samples were impacted at three different sites in the scarf joints (at the TN, the TF, and the CN) using the same energy level, with the intent to induce a barely visible impact damage with a corresponding dent depth of 0.01". The results clearly show that the residual strength of a damaged scarf joint depends on the damage location in the joint.

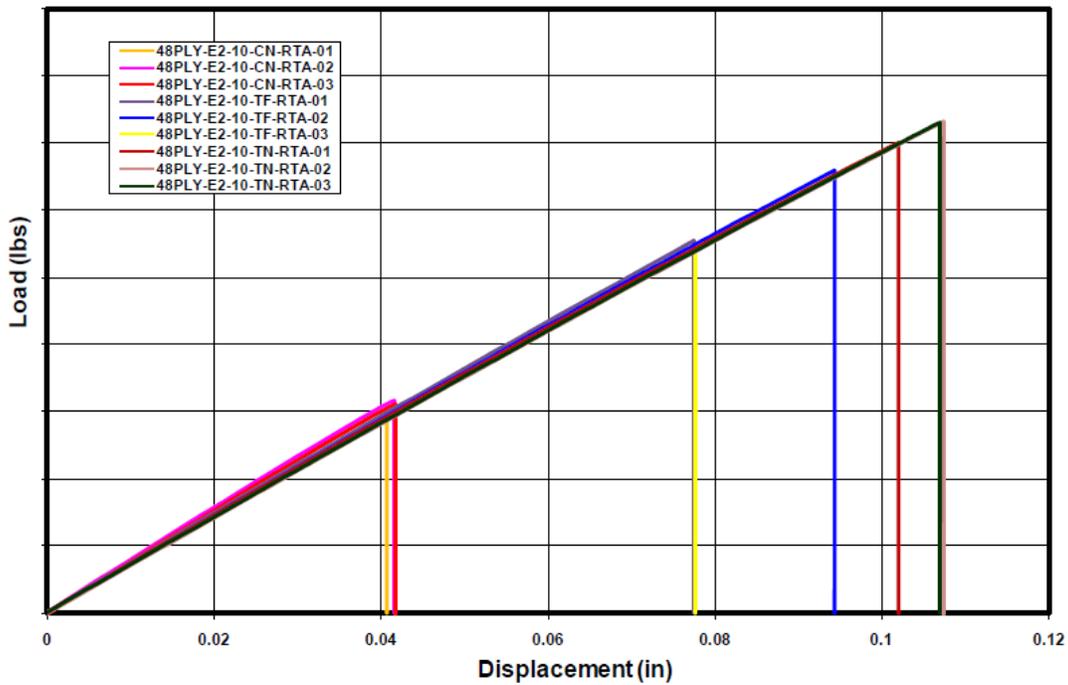
Figure 87. Representative load vs. displacement curves of damaged 48-ply laminate scarf repairs tested at room temperature (1:10 scarf rate)

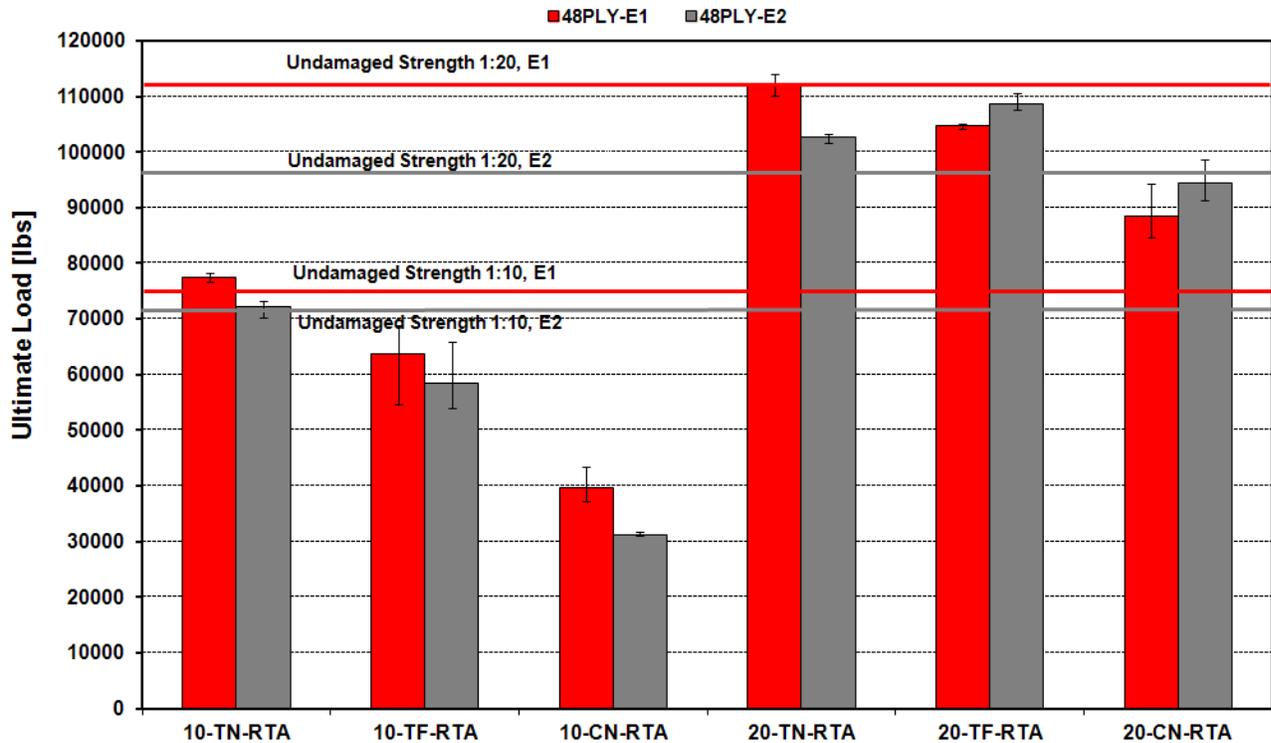
**Figure 88. Residual strength after damage (static strength) of 48-ply laminate scarf repair configurations**

The ultimate loads of the damaged scarf repairs were compared to those of pristine, undamaged repairs. The failure load values shown in figure 88 correlated very well with the C-Scan data summarized in figure 73; the specimens with the largest damage yielded the lowest residual strength. The 48-ply-TN specimens produced the highest residual strength regardless of scarf/repair size (smallest damage area), followed by the TF specimens, with the CN specimens yielding the lowest strengths (largest damage area). The magnitude of the strength degradation observed for the 1:10 scarf repairs was more severe than that observed for the 1:20 scarf repair samples. For the same impact energy level inflicted on the 1:10 and 1:20 scarf repairs, the percentage of residual structurally sound bonded area around the damage was higher for the larger scarf repairs (1:20).

Figure 89 shows a summary of the far field parent ultimate strains obtained for all static damaged scarf repairs tested at room temperature. The results of figure 88 correlated with those in figure 89. The TN specimens resulted in the highest residual strengths and corresponding far field parent ultimate strains (these samples had the smallest damage area) followed by the TF specimens and the CN specimens. The CN specimens yielded the lowest strengths and corresponding far field parent ultimate strains (largest damage area). The 48-ply-E1-10 configurations yielded average ultimate parent far field strains of  $6685\mu\epsilon$ ,  $5597\mu\epsilon$ , and  $3749\mu\epsilon$  for the TN, TF, and CN specimens, respectively. Similarly, the 48-ply-E2-10 configurations yielded average ultimate parent far field strains of  $4982\mu\epsilon$ ,  $4207\mu\epsilon$ , and  $2601\mu\epsilon$  for the TN, TF, and CN specimens, respectively.

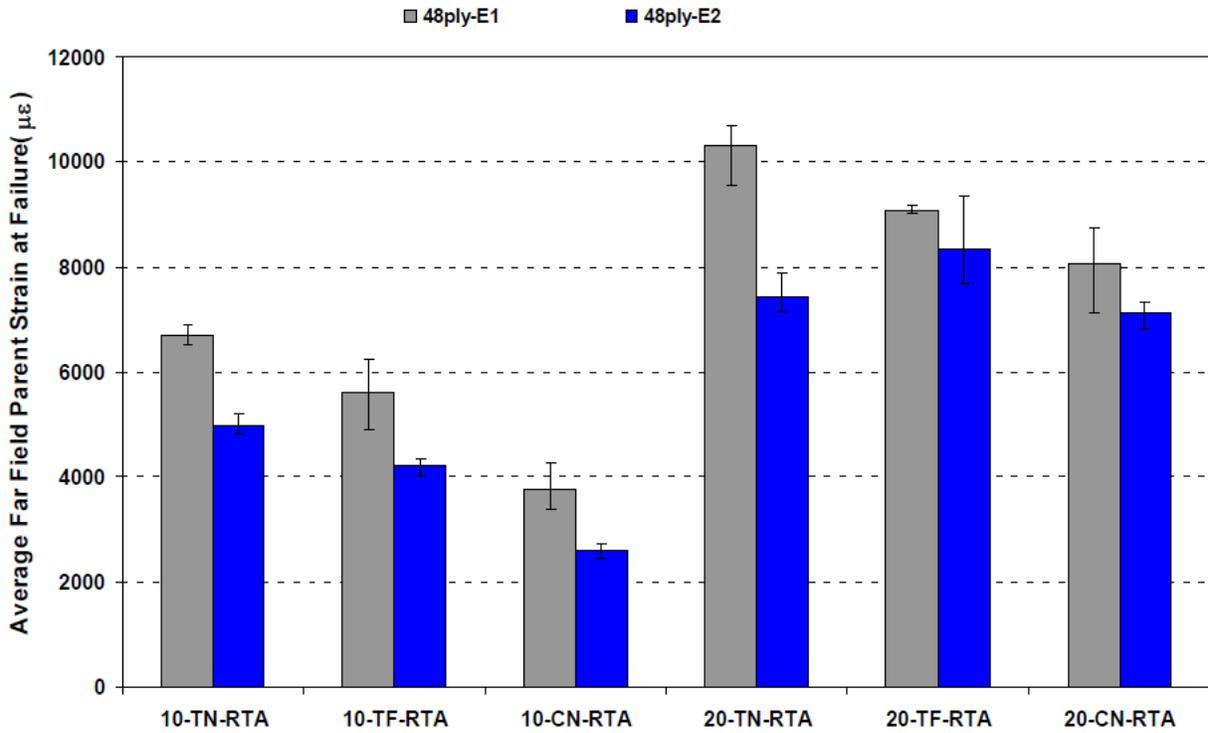
**Figure 89. Far field parent strain at failure of 48-ply laminate scarf repair configurations**

The 48-ply-E1-20 configurations yielded average ultimate parent far field strains of  $10302\mu\epsilon$ ,  $9051\mu\epsilon$ , and  $8056\mu\epsilon$  for the TN, TF, and CN specimens, respectively. Similarly, the 48-ply-E2-20 configurations yielded average ultimate parent far field strains of  $7429\mu\epsilon$ ,  $8345\mu\epsilon$ , and  $7113\mu\epsilon$  for the TN, TF, and CN specimens, respectively. The larger repairs (1:20) failed at higher strains than the smaller repairs, and the softer substrate (E1) yielded higher strains to failure than the stiffer substrate (E2). The mechanical data correlated very well with the impact data (damage area).

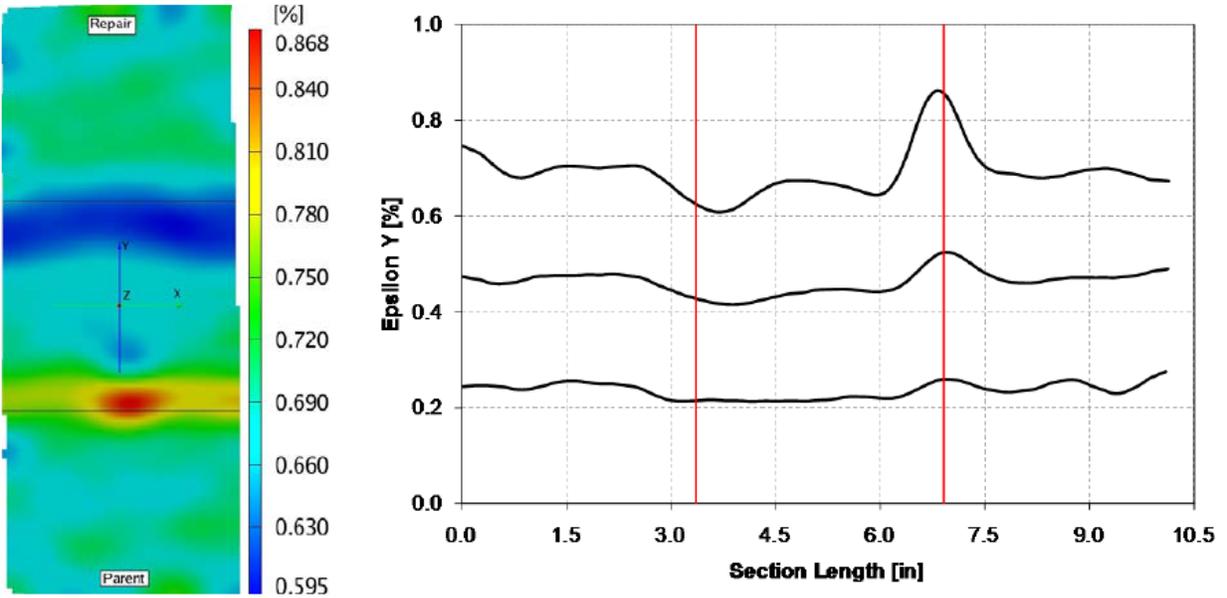
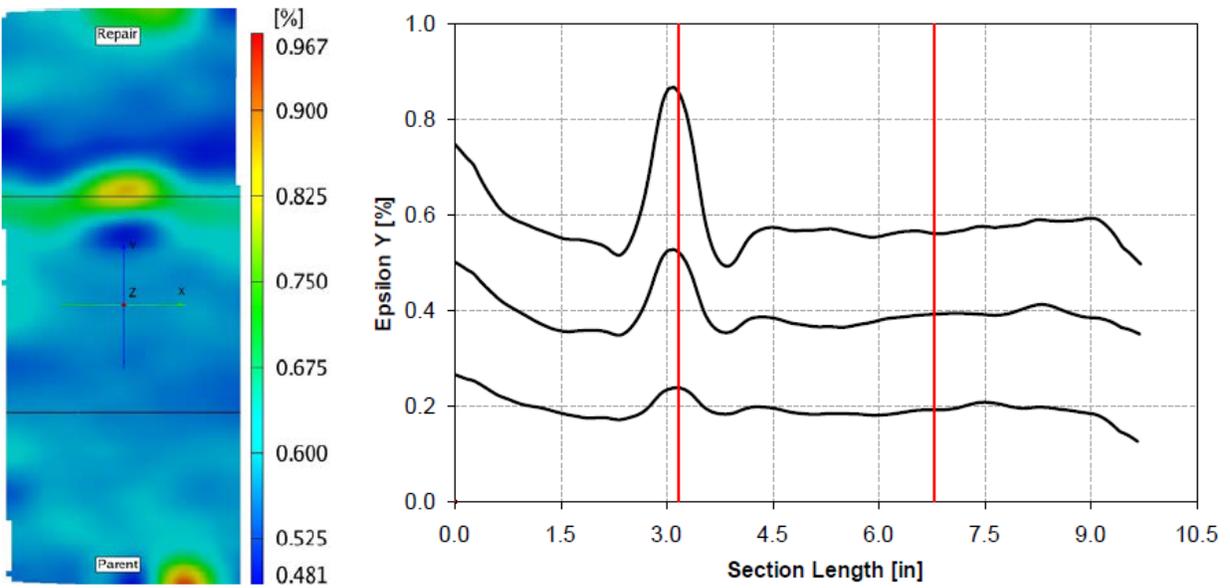
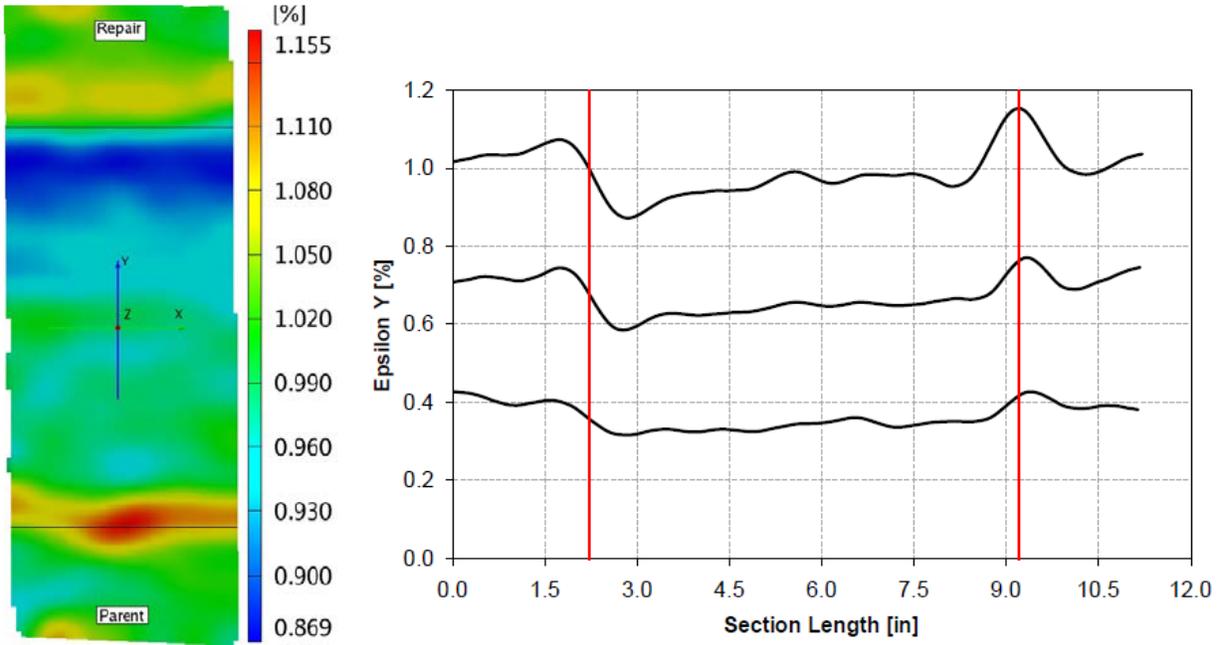
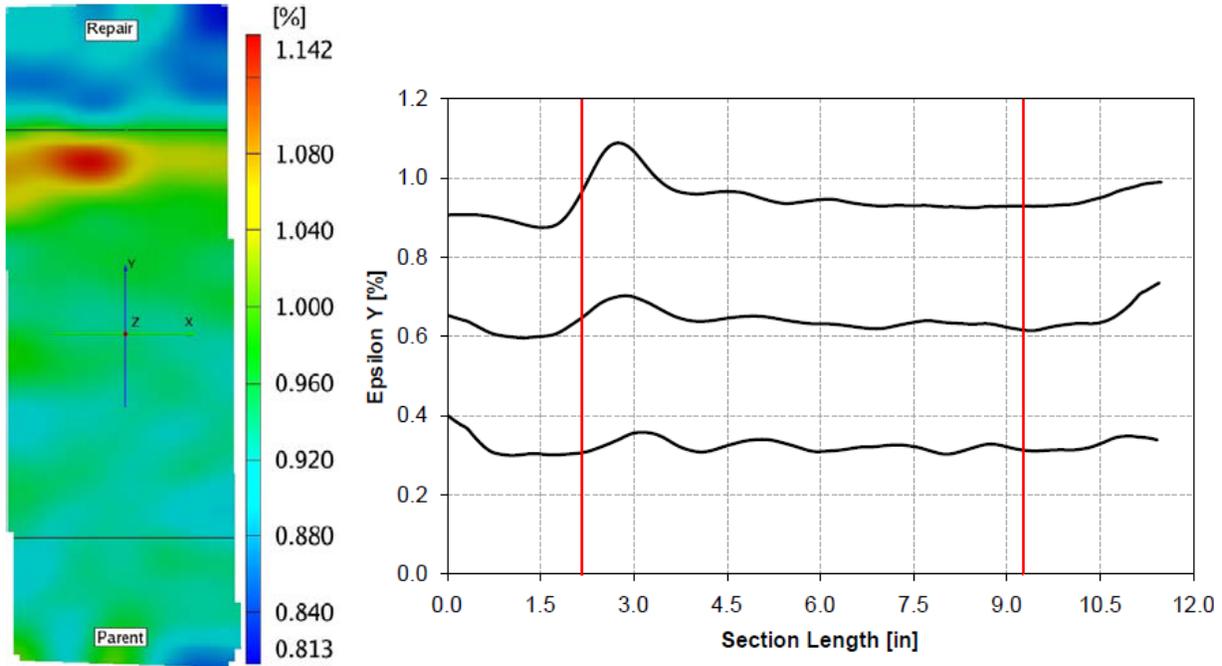
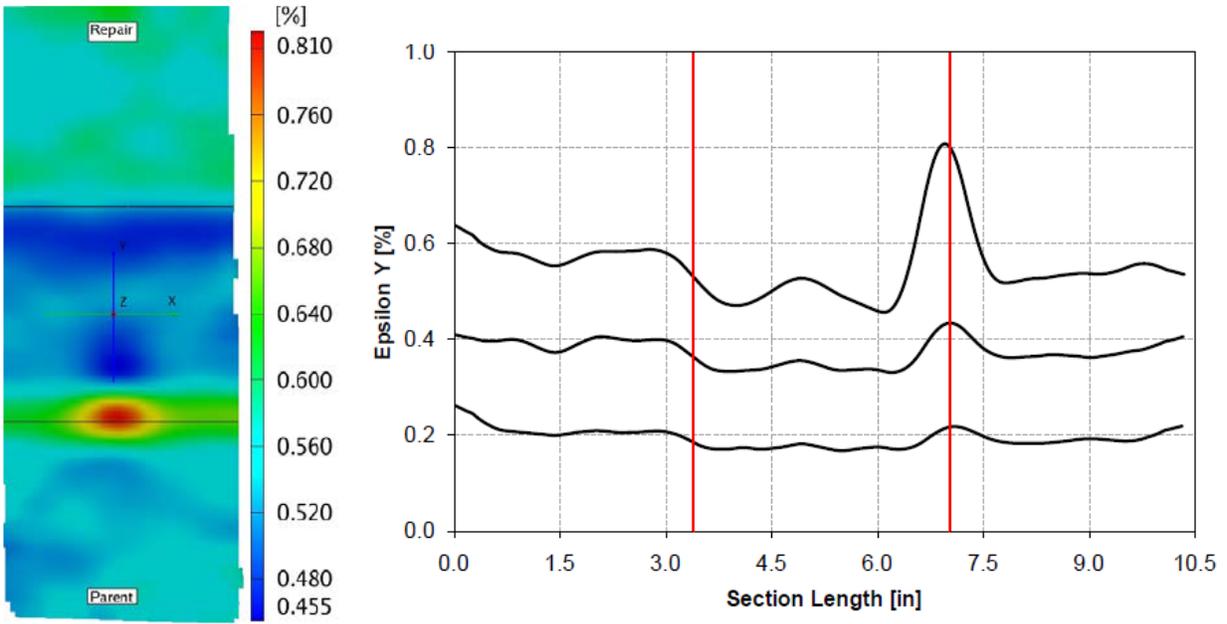
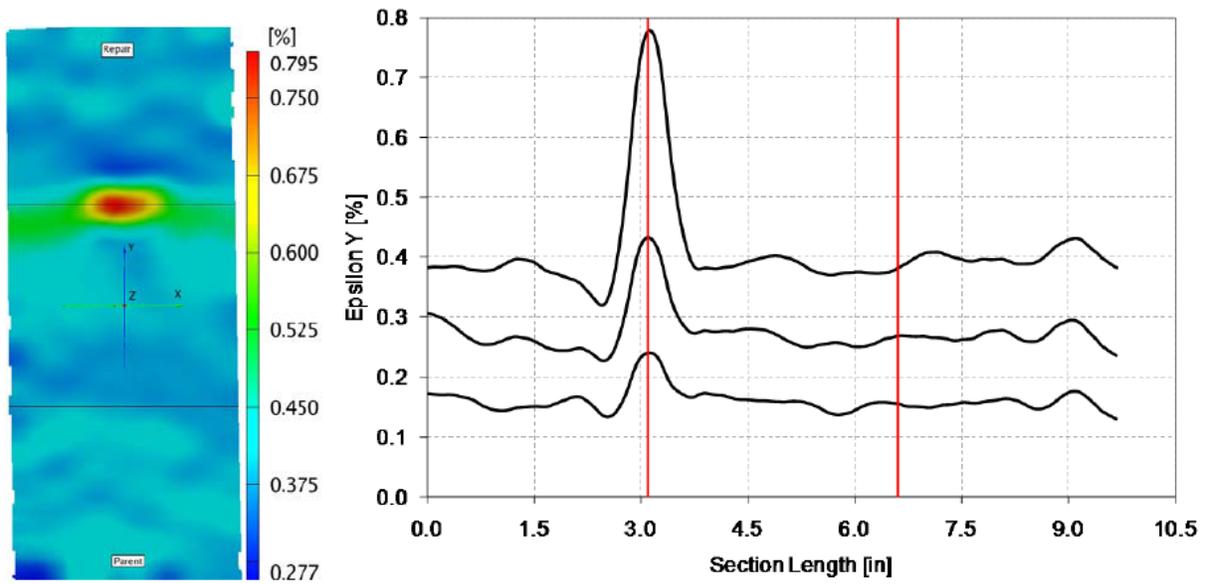
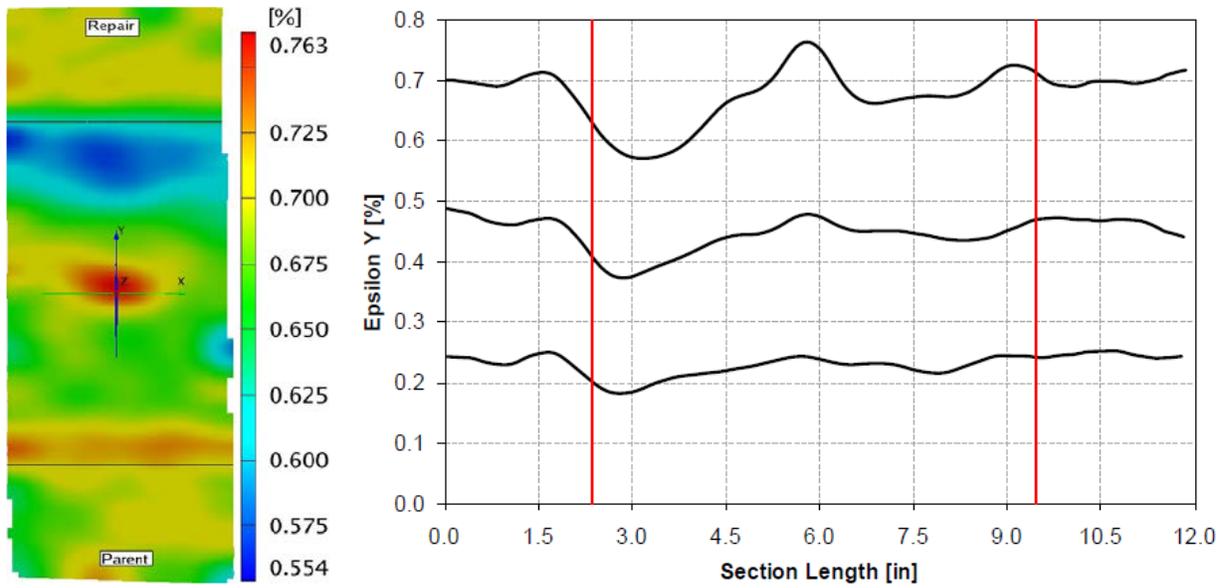
**Figure 90. Y-strain distribution 48-ply-E1-10-TN-RTA-2 scarf repair specimen**

**Figure 91. Y-strain distribution 48-ply-E1-10-TF-RTA-01 scarf repair specimen**

**Figure 92. Y-strain distribution 48-ply-E1-20-TN-RTA-03 scarf repair specimen**

**Figure 93. Y-strain distribution 48-ply-E1-20-TF-RTA-01 scarf repair specimen**

**Figure 94. Y-strain distribution 48-ply-E2-10-TN-RTA-2 scarf repair specimen**

**Figure 95. Y-strain distribution 48-ply-E2-10-TF-RTA-2 scarf repair specimen**

**Figure 96. Y-strain distribution 48-ply-E2-20-CN-RTA-03 scarf repair specimen**

Figures 90–96 are representative y-strain maps and corresponding longitudinal y-strain section plots lengthwise through the center of specimens impacted at the TN, TF, and CN, respectively.

The impact site created a stress riser at the damage location, which appears to be the locus of failure initiation, as shown in the figures.

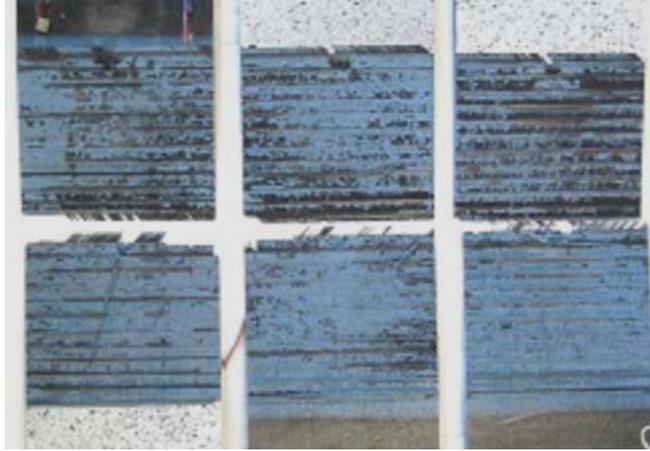
**Figure 97. Failure modes: 48-ply-E2-10-TN-RTA**

Failure modes were very consistent for all specimens tested at room temperature and all specimens failed in the scarf joint. The dominant failure mode was a cohesive failure of the adhesive mainly in the 45 and 0 plies and a 90 ply peel/tension failure as shown in figures 97 and 98. For the specimens impacted at the CN, a visible disbond in the bondline was observed after failure, as shown in figures 98 and 99. It should be noted that figure 99 is shown for illustration purposes only as the environmental tests were not included in the scope of this study.

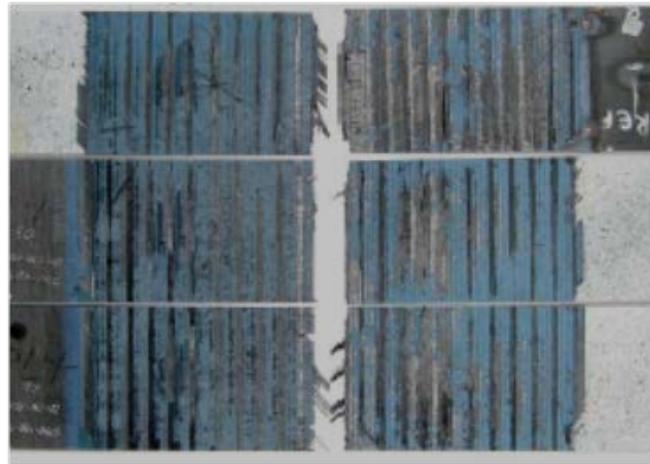
**Figure 98. Failure modes 48-ply-E2-20-CN-RTA**

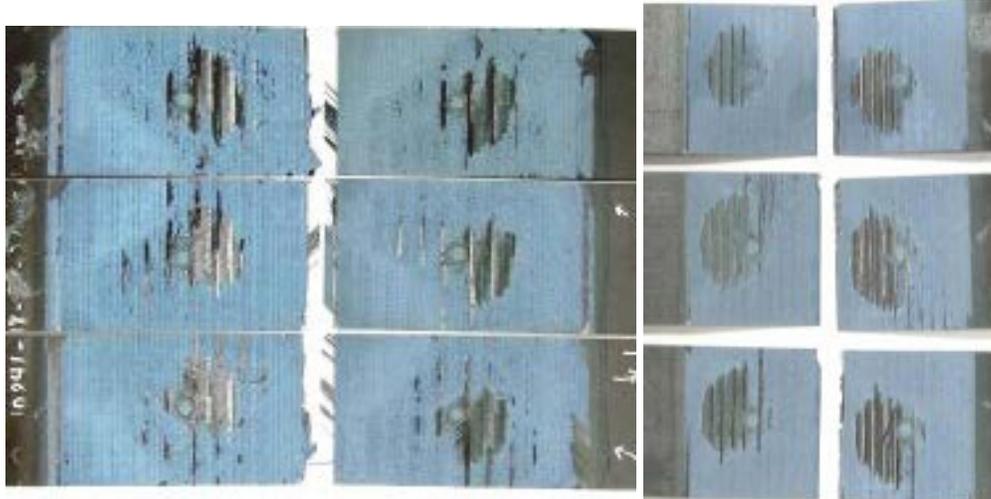
**Figure 99. Failure modes, environmental tests, 48-ply-E2-20-CN/48-ply-E1-10-CN (showing disbond/damage to the bondline due to impact at the center of the specimen)**

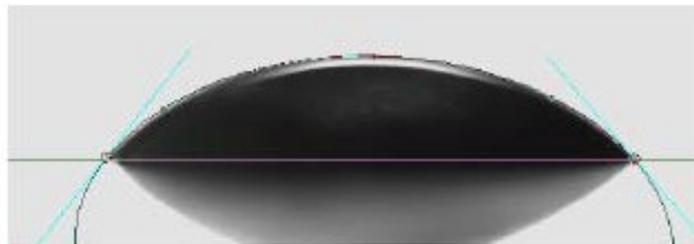
**Figure 100. Low contact angle**

measured, as shown in figures 100–102. Low, medium, and high contact angles were achieved depending on the degree of wetting of the water (liquid used for analysis) with respect to the analyzed surface.

A low contact angle, shown in figure 100, was achieved for surfaces contaminated with SH, PR, and WA75 (scarfed panels that have reached moisture equilibrium and then dried back to 75% of the moisture equilibrium/saturation level). A low contact angle shows good surface wetting, but this does not necessarily mean that a good bond would be achieved. A medium contact angle was achieved with baseline uncontaminated specimens and WA0 panels, as shown in figure 101. A high contact angle was achieved with JF-contaminated scarfed panels, as shown in figure 102. A low contact angle yields a high SFE, whereas a high contact angle yields a low SFE. A high SFE yields efficient wetting before cure, but does not necessarily mean a good bond would be achieved. A surface contaminated with polar compounds analyzed with water yields a high SFE, but not necessarily a good bond. Contaminated surfaces with SH, PR, and WA75 had a high SFE, but a poor bond. All contact angle/SFE experiments used water as the testing liquid. Water is a very polar liquid (with a powerful permanent dipole caused by the hydrogen adopting a partial positive charge and the oxygen a partial negative charge). This allows the water molecule to strongly bind to polar sites on the scarfed surface.

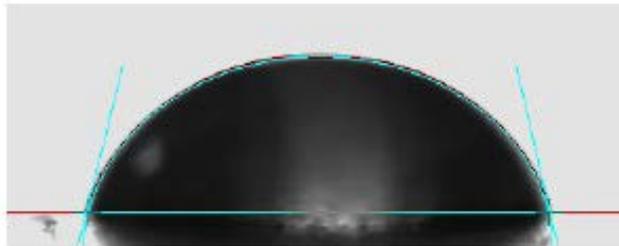
**Figure 101. Medium contact angle**

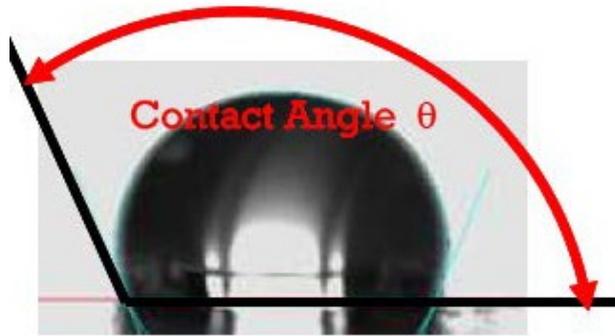
**Figure 102. High contact angle**

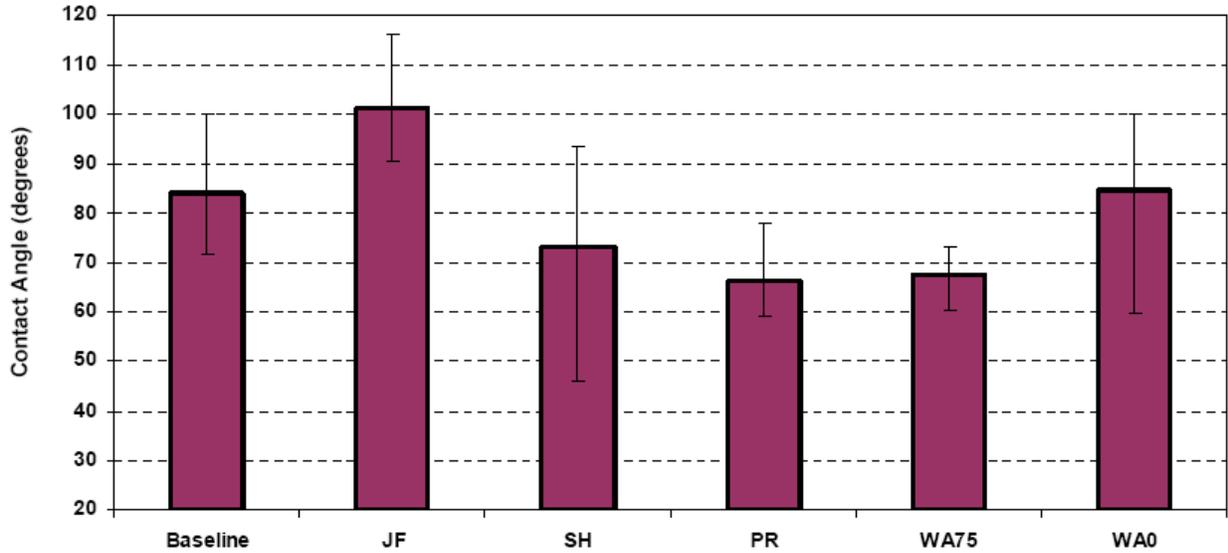
**Figure 103. Contact angle measurements**

The scarfed laminates contaminated with JF exhibited a low SFE because the JF, unlike water, SH, and PR, is a non-polar compound, thus, repelling the very polar water droplet. The water molecules in the water droplet tended to bind to themselves, rather than to the JF-contaminated scarfed surface, as shown in figure 102. This results in a large contact angle with a water droplet and a low apparent SFE. This would lead to poor spreading of the repair adhesive over the scarfed surface. Figures 103 and 104 show the contact angle and apparent SFE results. As shown in the figures, the JF-contaminated panels yielded the highest contact angles and the lowest SFE. The SH-, PR-, and WA75-contaminated panels yielded the lowest contact angles (the most efficient wetting) and the highest SFEs.

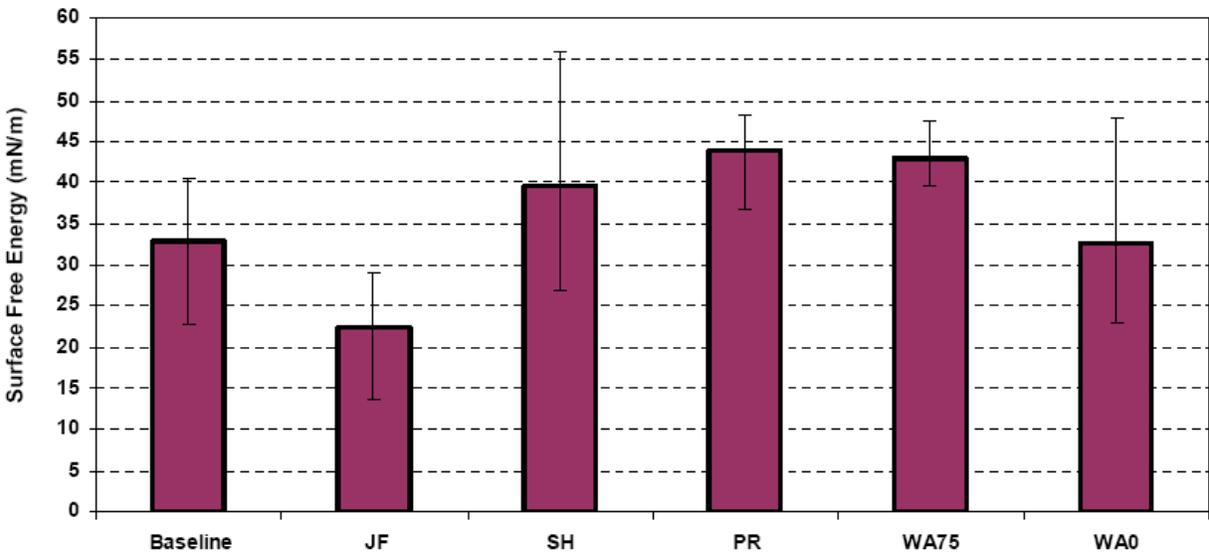
**Figure 104. SFE measurements**

The scarfed laminates contaminated with SH exhibited a high SFE because SH is a highly polar compound, thus, attracting the highly polar water drops, which in turn wet the surface. The SH and its additive package could possibly interfere with the adhesive cure reaction.

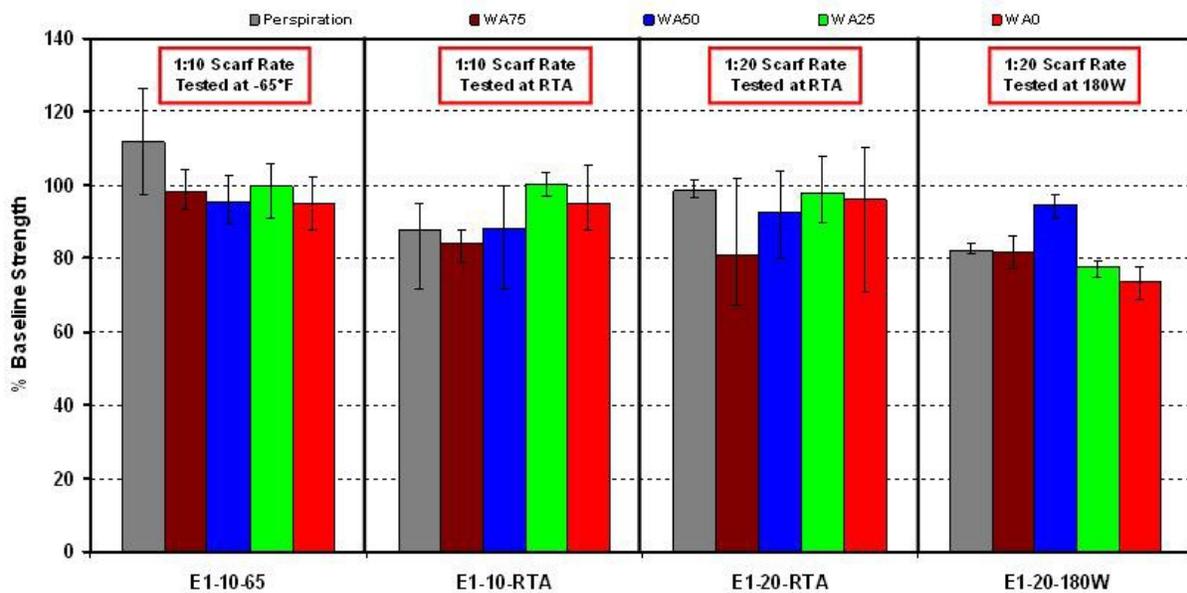
**Figure 105. Normalized strength of PR- and water-contaminated panels (E1 lay-up)**

Figures 105–108 show the normalized ultimate strength results of contaminated scarf repairs tested to failure at cold temperature (-65°F), RTA, and elevated temperature wet (180W) for substrates of two different stiffnesses (E1 and E2). E1 corresponds to a quasi-isotropic lay-up, whereas E2 corresponds to a stiff lay-up. Two different scarf rates, 1:10 and 1:20, were considered for this study. The 1:10 scarf rate specimens were tested at cold and room temperature, whereas the 1:20 scarf rate specimens were tested at room temperature and elevated temperature wet.

Failure loads for each of the four configurations shown in figure 105 were normalized with respect to the average ultimate load of the uncontaminated joints for that configuration tested at the same temperature. All contaminated samples from configuration 1 (1:10 scarf rate tested at -65°F) were normalized with respect to the average ultimate load of the uncontaminated 1:10 scarf joints tested at -65°F. Similarly, all contaminated samples from configuration 2 (1:10 scarf rate tested at RTA) were normalized with respect to the average ultimate load of the uncontaminated 1:10 scarf joints tested at RTA.

Figure 105 shows significant scatter in the contamination results obtained across environmental conditions. Specimens exposed to PR yielded a maximum average strength degradation of 18% for the 1:20 scarf rate specimens tested at 180W (E1-20-180W). The minimum individual data point recorded for all PR-contaminated specimens corresponds to 28% strength reduction (1:10 scarf rate tested at RTA). Specimens exposed to WA75 yielded a maximum average strength degradation of 19% for the 1:20 scarf rate specimens tested at RTA (E1-20-RTA). The minimum individual data point recorded for all WA75-contaminated specimens yielded 33% strength reduction with respect to the baseline uncontaminated strength of the same joint (1:20 scarf rate tested at RTA).

Specimens exposed to WA50 yielded a maximum average strength degradation of 12% for the 1:10 scarf rate specimens tested at RTA (E1-10-RTA). The minimum individual data point recorded for all WA50 contaminated specimens yielded 28% strength reduction with respect to the baseline uncontaminated strength of the same joint (1:10 scarf rate tested at RTA). Specimens exposed to WA25 yielded a maximum average strength degradation of 23% for the 1:20 scarf rate specimens tested at 180W (E1-20-180W). The minimum individual data point recorded for all WA25-contaminated specimens yielded 25% strength reduction with respect to the baseline uncontaminated strength of the same joint (1:20 scarf rate tested at 180W).

Specimens exposed to WA0 yielded a maximum average strength degradation of 27% for the 1:20 scarf rate specimens tested at 180W (E1-20-180W). The minimum individual data point recorded for all WA0 specimens yielded 31% strength reduction with respect to the baseline uncontaminated strength of the same joint (1:20 scarf rate tested at 180W). These results suggest that drying the samples did not restore the original strength of these repairs.

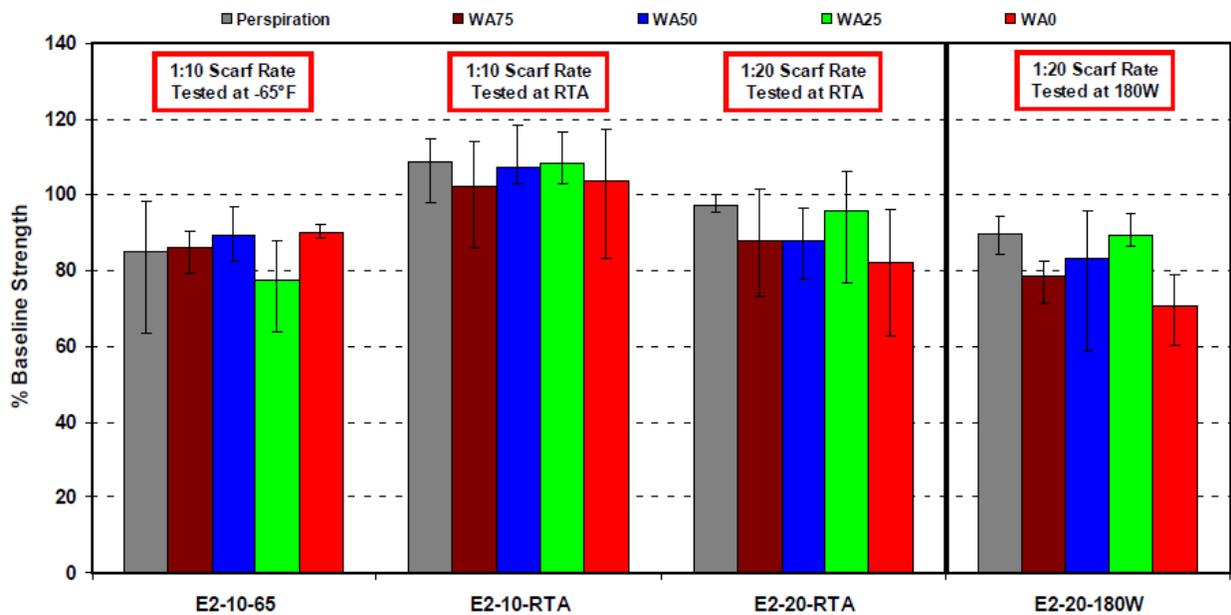
**Figure 106. Normalized strength of PR- and water-contaminated panels (E2 lay-up)**

As shown in figure 106, specimens exposed to PR yielded a maximum average strength degradation of 15% for the 1:10 scarf rate specimens tested at -65°F (E2-10-65). The minimum individual data point recorded for all PR-contaminated specimens corresponds to 37% strength reduction (1:10 scarf rate tested at -65°F). Specimens exposed to WA75 yielded a maximum average strength degradation of 21% for the 1:20 scarf rate specimens tested at 180W (E2-20-180W). The minimum individual data point recorded for all WA75-contaminated specimens yielded 29% strength reduction with respect to the baseline uncontaminated strength of the same joint (1:20 scarf rate tested at 180W).

Specimens exposed to WA50 yielded a maximum average strength degradation of 17% for the 1:20 scarf rate specimens tested at 180W (E2-20-180W). The minimum individual data point recorded for all WA50-contaminated specimens yielded 41% strength reduction with respect to

the baseline uncontaminated strength of the same joint (1:20 scarf rate tested at 180W). Specimens exposed to WA25 yielded a maximum average strength degradation of 23% for the 1:10 scarf rate specimens tested at -65°F (E2-10-65). The minimum individual data point recorded for all WA25-contaminated specimens yielded 36% strength reduction with respect to the baseline uncontaminated strength of the same joint (1:10 scarf rate tested at -65°F).

Specimens exposed to WA0 yielded a maximum average strength degradation of 29% for the 1:20 scarf rate specimens tested at 180W (E2-20-180W). The minimum individual data point recorded for all WA0 specimens yielded 40% strength reduction with respect to the baseline uncontaminated strength of the same joint (1:20 scarf rate tested at 180W). With the exception of the E2-10-RTA configurations, static data showed a lower static strength for panels contaminated with PR, WA75, WA50, WA25, and WA0 (compared to the baseline/uncontaminated joint strength).

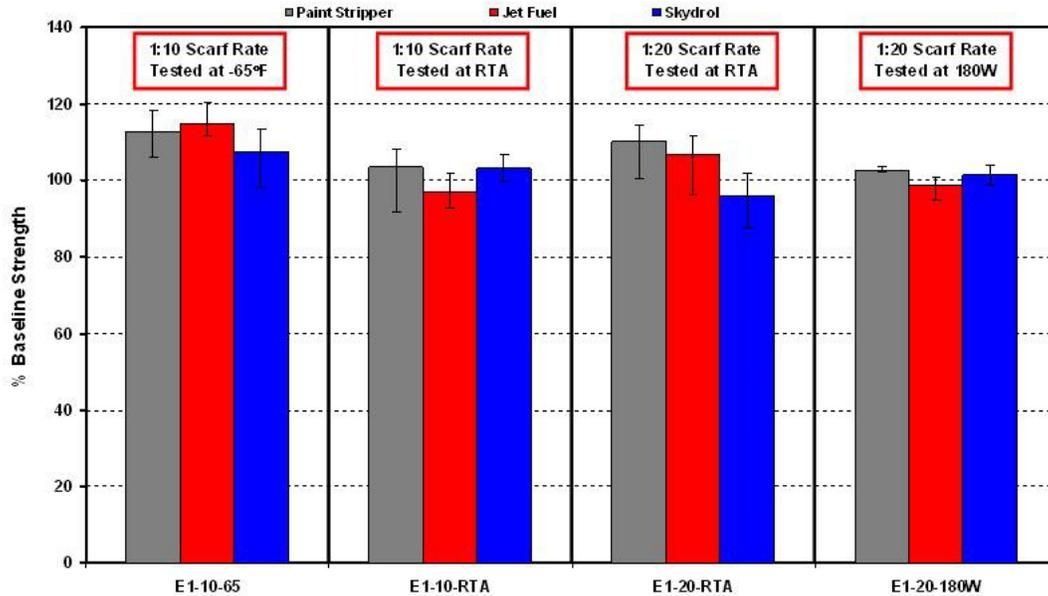
Figure 107. Normalized strength of PS-, JF-, and SH-contaminated panels (E1 lay-up)

As shown in figure 107, the minimum individual data points recorded for all PS-, JF-, and SH-contaminated specimens correspond to 8% strength reduction for PS (1:10 scarf rate tested at RTA), 5% strength reduction for JF (1:10 scarf rate tested at RTA), and 12% strength degradation for SH-contaminated panels. As shown in figure 108, the minimum individual data points recorded for all PS-, JF-, and SH-contaminated specimens correspond to 9% strength reduction for PS (1:10 scarf rate tested at RTA), 5% strength reduction for JF (1:20 scarf rate tested at RTA), and 6% strength degradation for SH-contaminated panels.

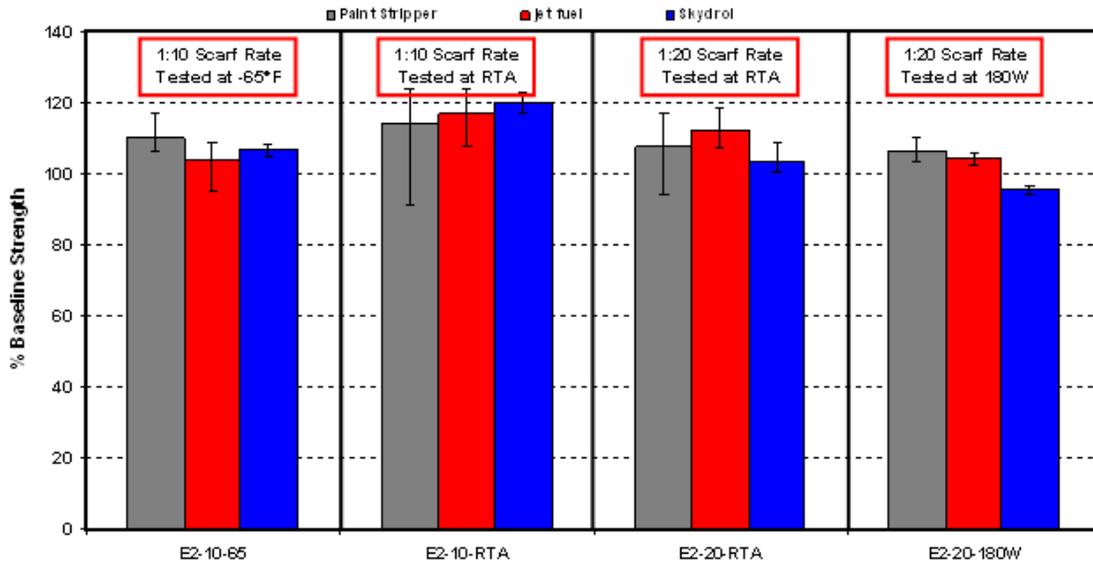
Figure 108. Normalized strength of PS-, JF-, and SH-contaminated panels (E2 lay-up)

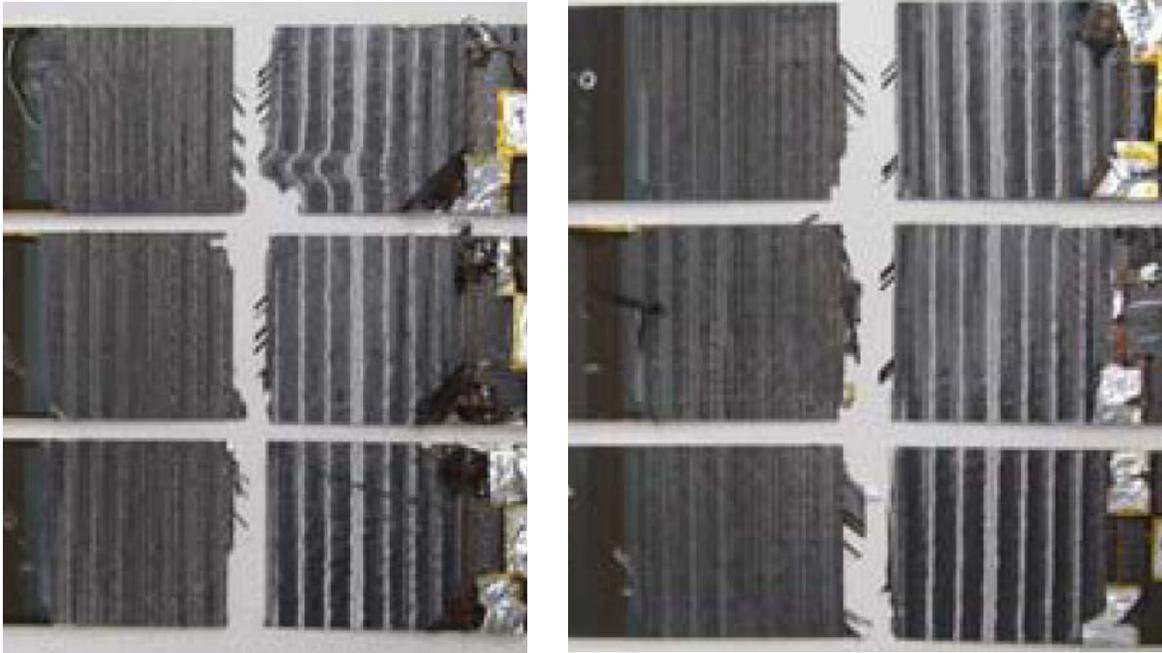
**Figure 109. Failure modes 32-ply-E1-20-JF-180W/32-ply-E1-20-PR-180W**

Failure modes were very consistent for all specimens within the same test conditioning environment. The dominant failure mode for the specimens tested at room temperature and at -65°F was a combination of an adhesive failure and a 45°/90° ply failure in the scarf joint. The elevated temperature wet specimens all yielded adhesion failures, as shown in figures 109 and 110.

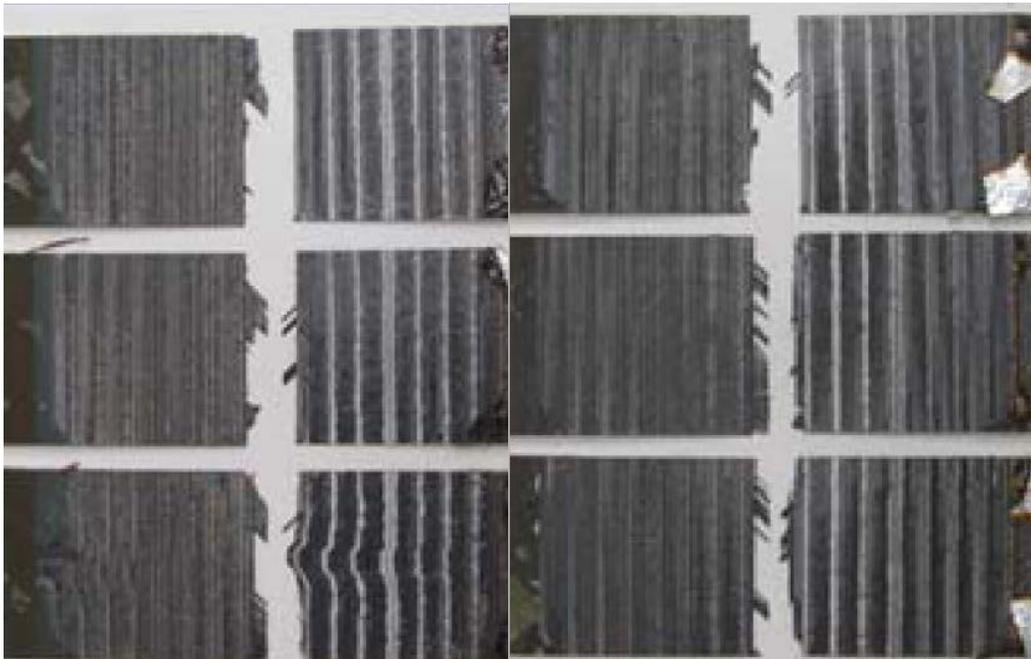
**Figure 110. Failure modes 32-ply-E1-20-SH-180W/32-ply-E1-20-WA75-180W**
